Snow Transmission Type HR300P

Service and Repair Manual

Transmission réf.
(87022-A)

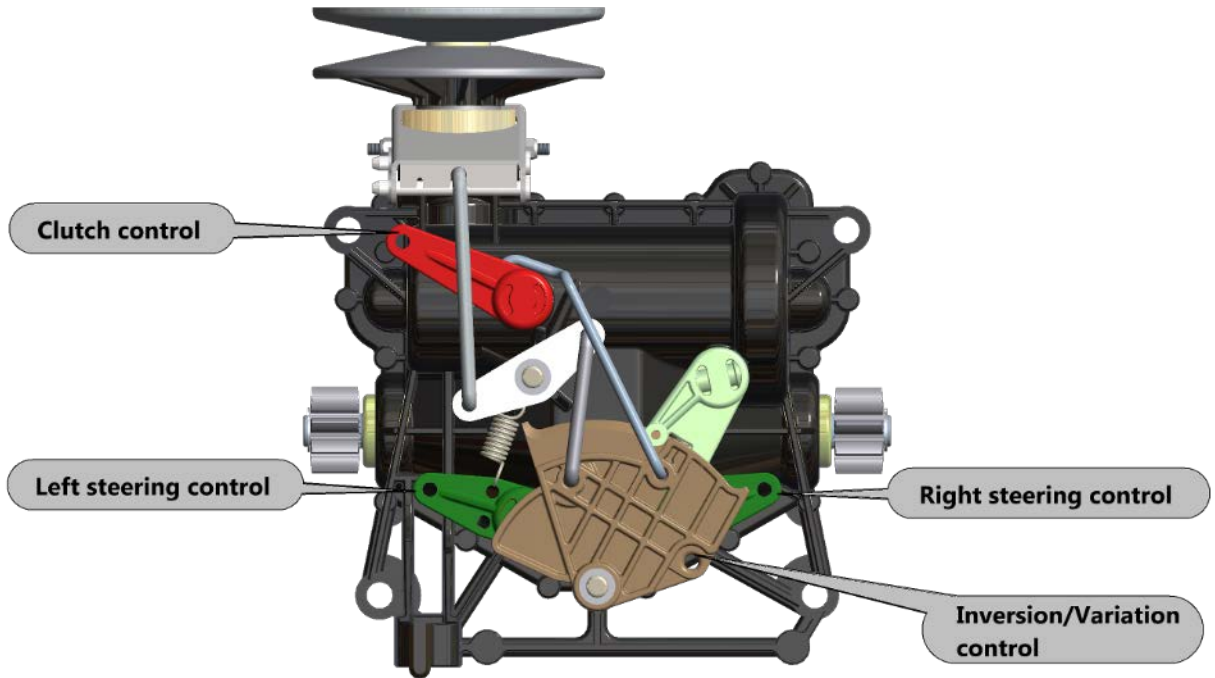
External Controls and Functions

The HR300P transmission is design to provide an infinitely variable speed range and reverse operation thru a single hand control, for dual stage snow thrower. This transmission also offer a steering control.

- Remove bottom cover and belt cover (see owner manual).
- Make sure that the belt is properly seated in both, engine and transmission pulleys.
- Verify clutch and steering cable (see view p.3).
- Verify link between handlebar and variation control (see view p. 3).

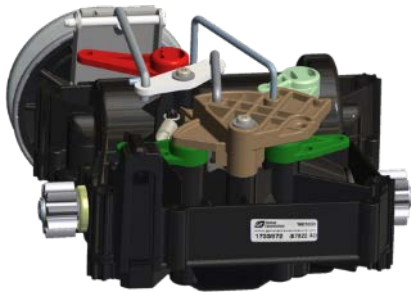
Product identification

-The product identification is located on the rear of the transmission.

Manufacturing day

Ex: 160, means 8th of June

Manufacturing year

Ex: **1** for the year 201**1**

Nth product of the day

Ex: 33rd product of the day

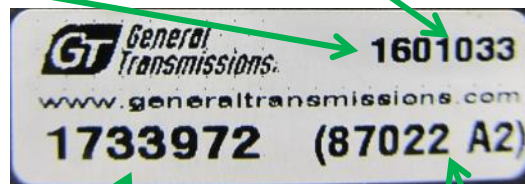
Customer P/N

General Transmissions P/N

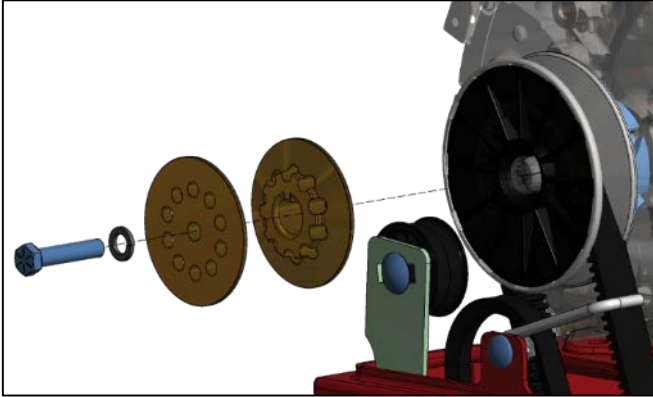
-After removing the belt cover (see owner manual), remove the auger drive pulley.

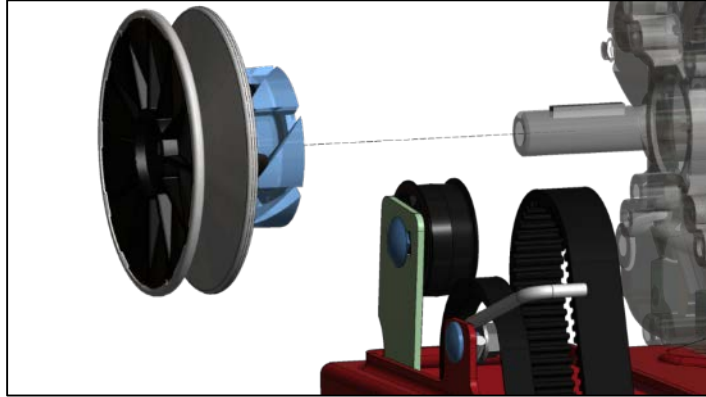
-Remove the driver pulley.

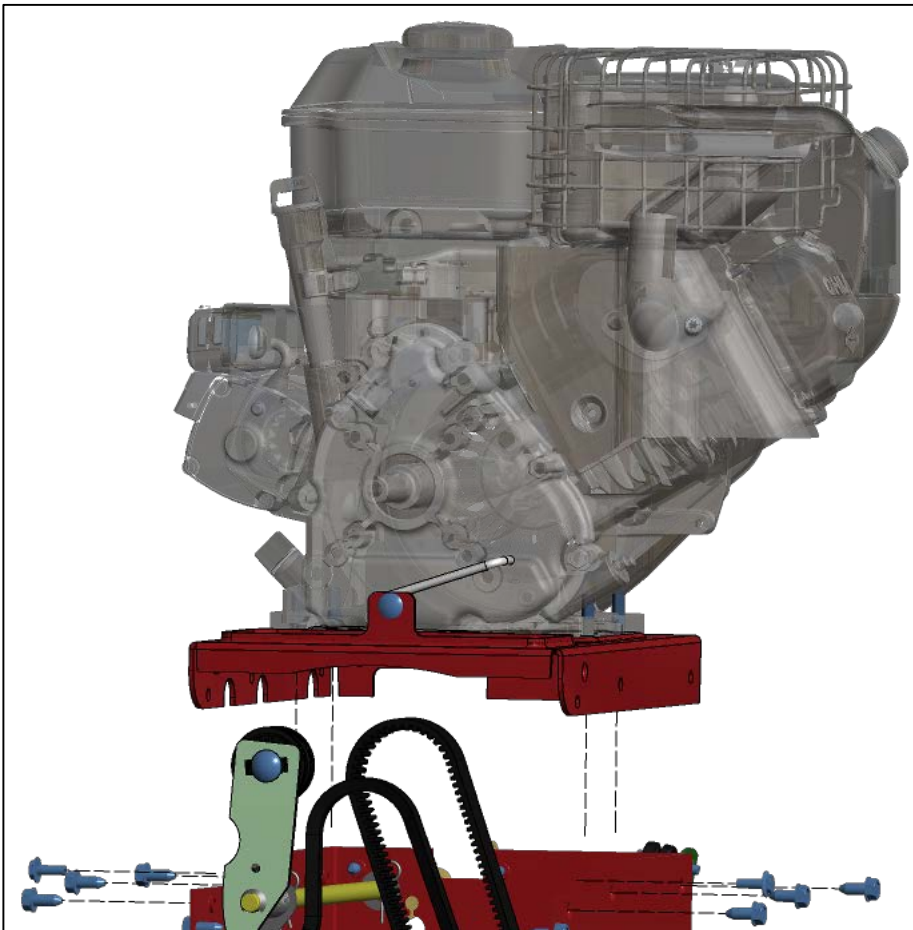
-Disconnect and remove the engine to access the transmission.

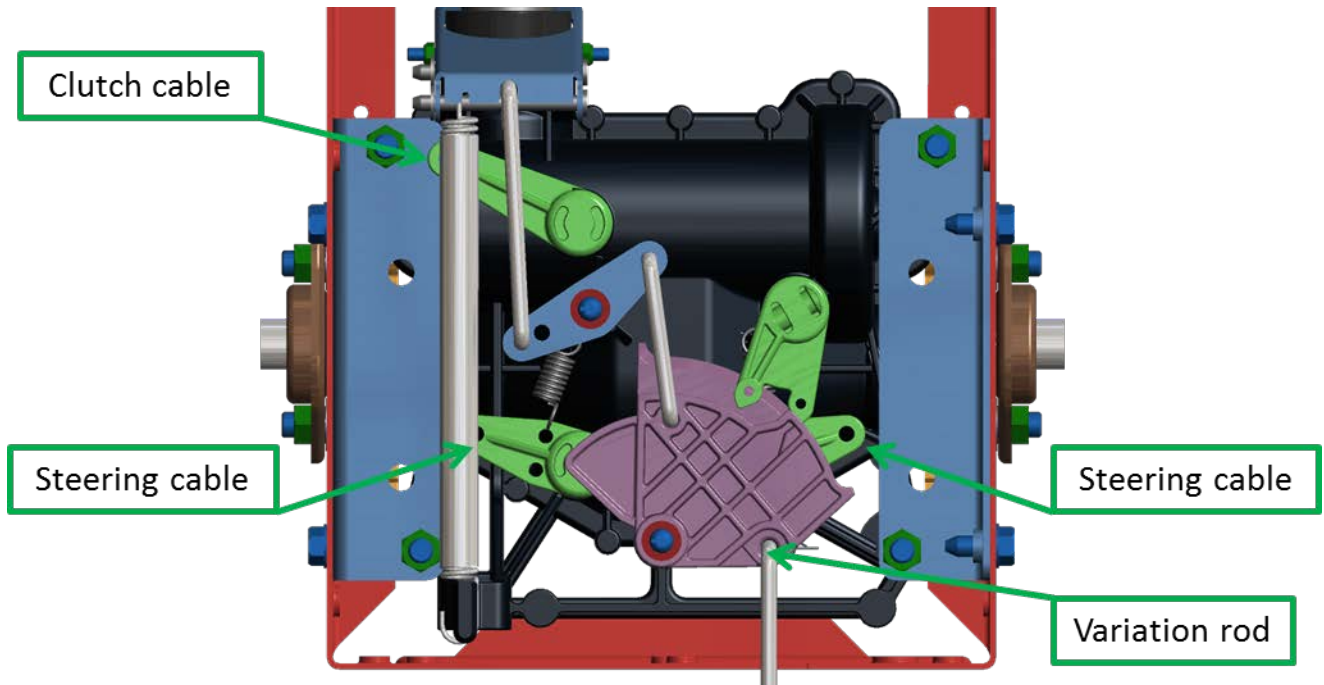
-Disconnect from the transmission:

- Clutch cable
- both steering cable
- variation rod

You may need to disconnect first from the handlebar, to be able to disconnect them from the transmission.

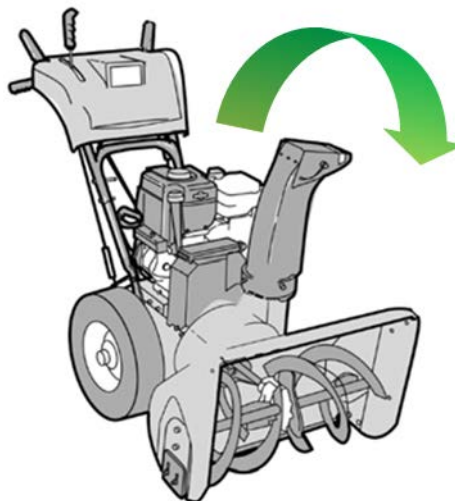
-Tip the machine forward, then remove the lower cover (see owner manual).

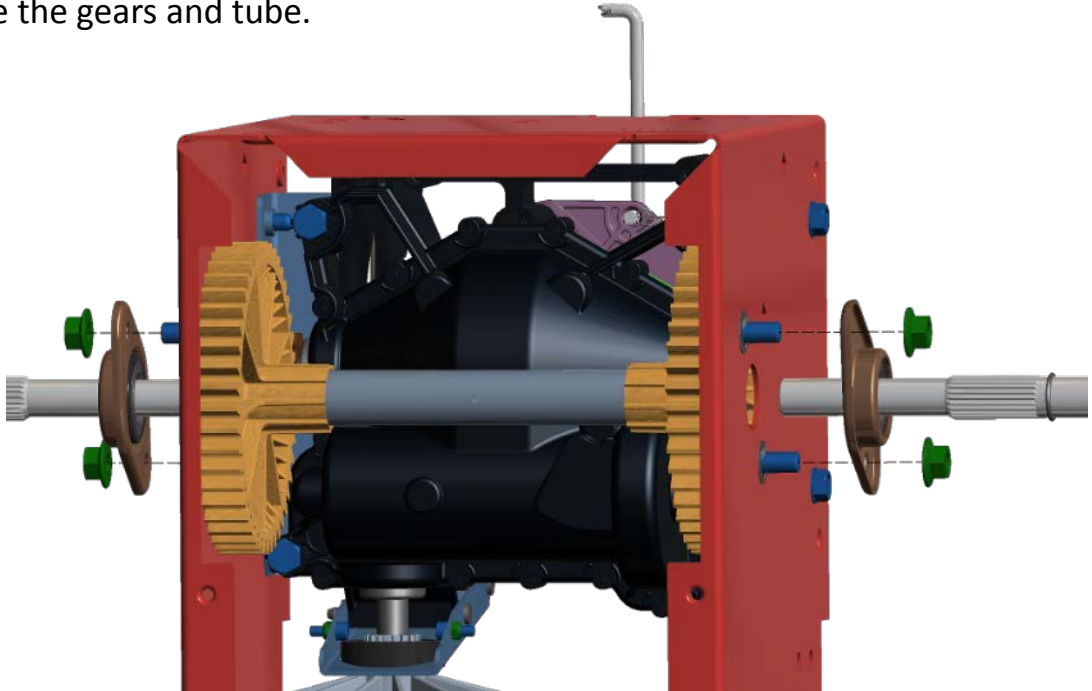
-After removing the wheels (see owner manual), remove the both axle shaft to liberate the gears and tube.

-See how to remove the axle shaft on page 7.

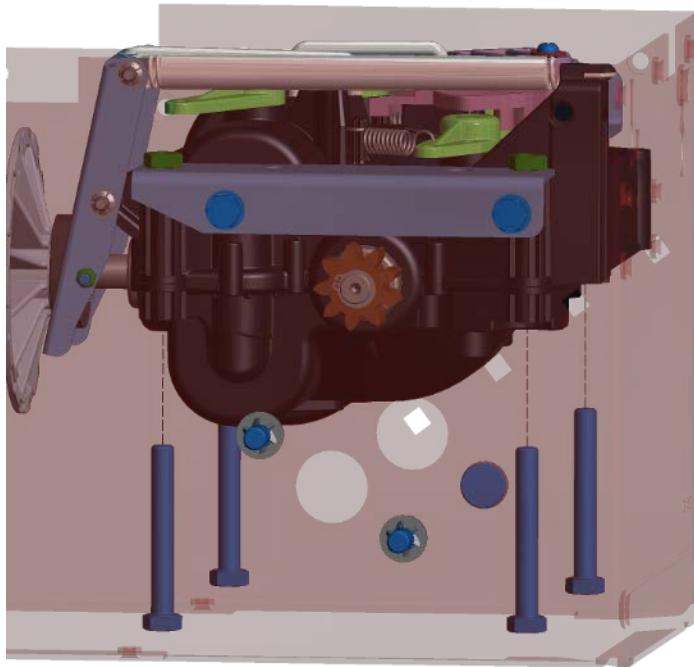
-Unscrew the 4 bolts, then remove the transmission to the bottom of the frame.

Screwing torque when reassembling: 9,5±2 lb-ft

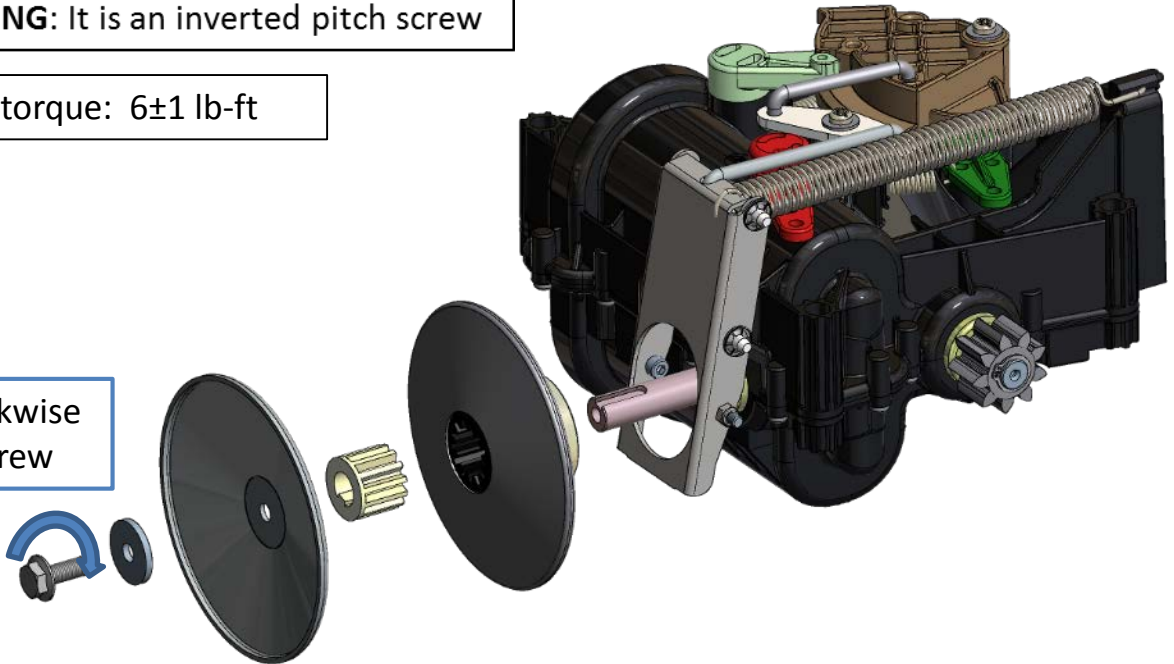
- In case of melting belt or flange, both pulleys and belt need to be replaced.
- To take off the driven pulley, remove the screw located at the end of the input shaft, using a 7/16" or 11mm socket.

**WARNING:** It is an inverted pitch screw

Screwing torque: 6 ± 1 lb-ft

Turn clockwise
to unscrew

- I- Broken control cam, inversion lever or main spring
- See how to tear down the transmission on page 7.
- Remove the driven pulley, as shown page 10.

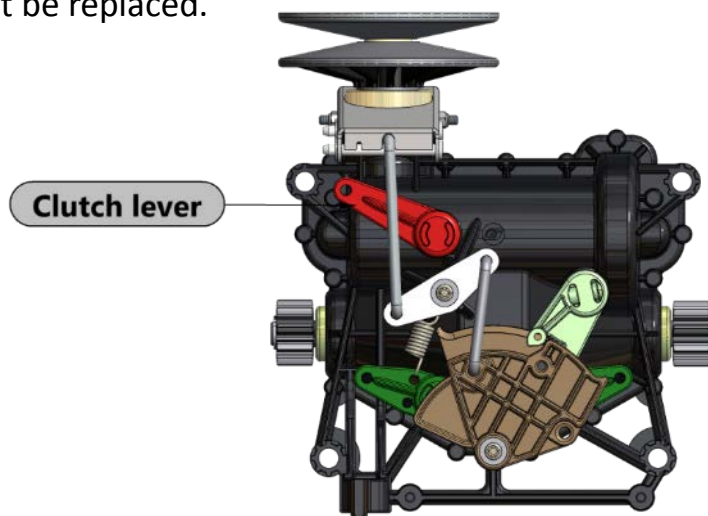
- For clutch cable or spring failure, see owner manual.
- Clutch lever cannot be replaced as an external component. In case of broken lever, the transmission must be replaced.

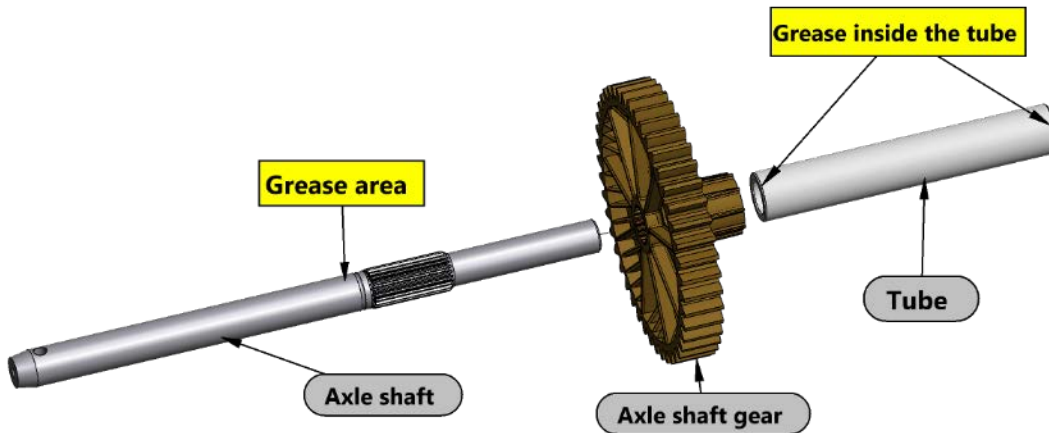
I- Broken axle shaft or axle shaft gear

-When reinstalling the new parts, put grease in the tube and on the axle shaft bushing area.

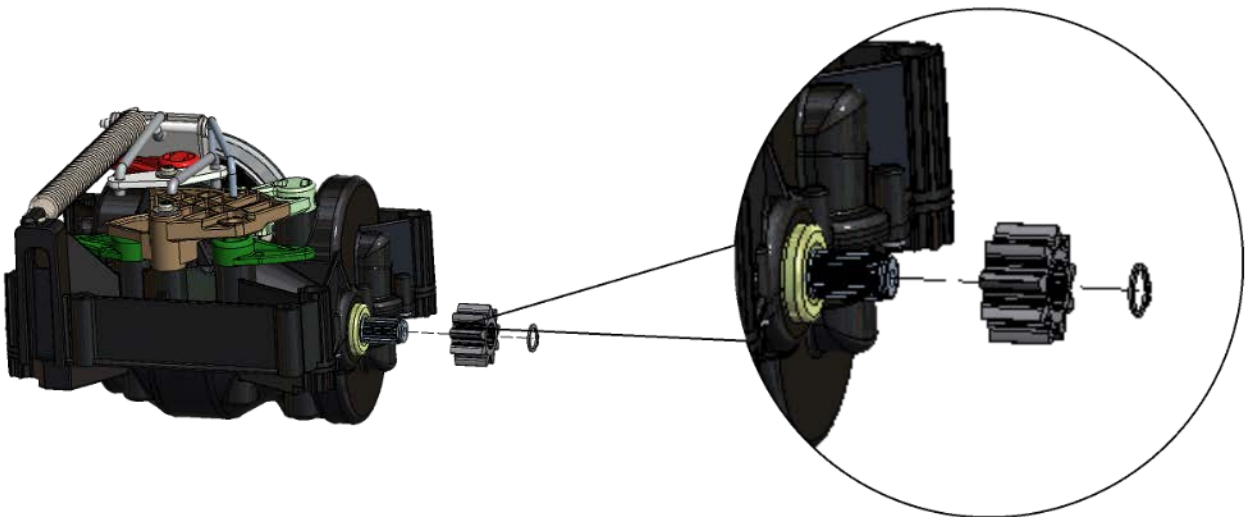
-Loss of traction on one side may result of a output shaft gear defect or loss.

-When positioning the new clip, make sure to not deformed it

-Defected output shaft gear may have damaged the axle shaft gear. Make sure to replace all necessary components.

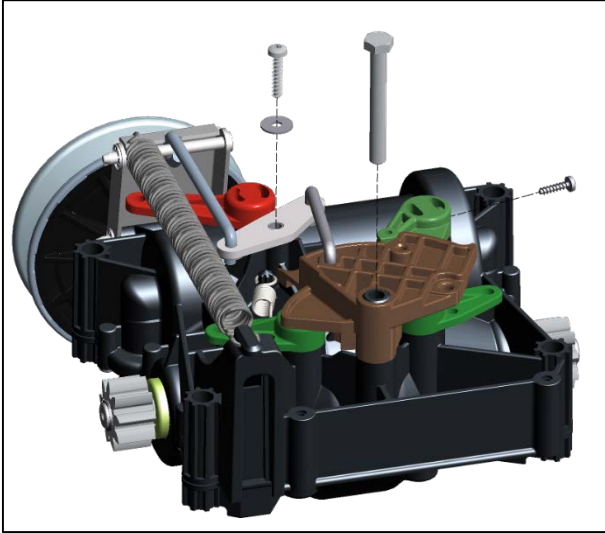
Remove the 3 screws

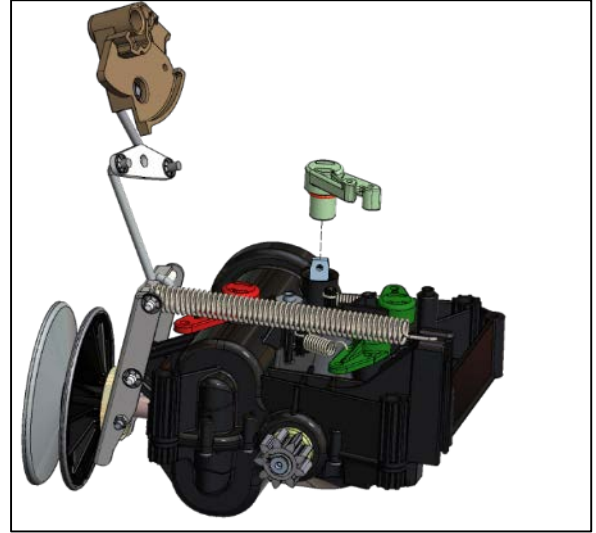
Remove the lever and rotate the control system

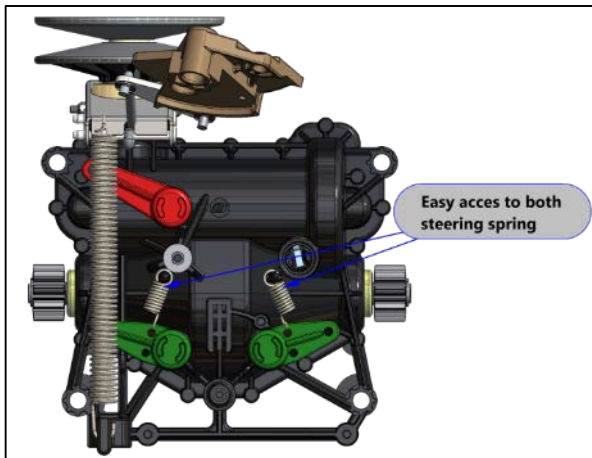
Access to both spring

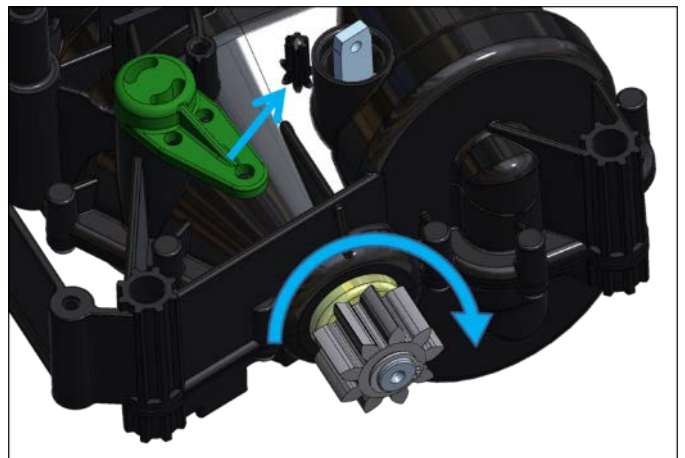
May need to turn the output shaft, to put the steering lever in position

- When reinstalling, we recommend to put sealant in the inversion lever to avoid any seepage.

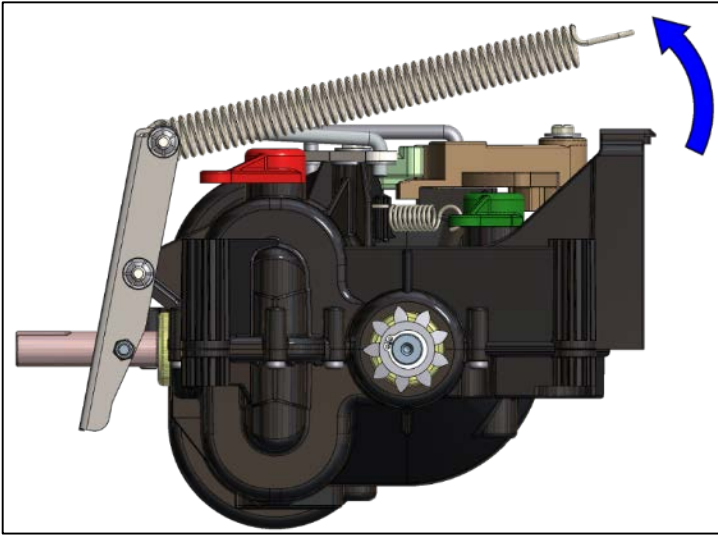
Unhook the main spring

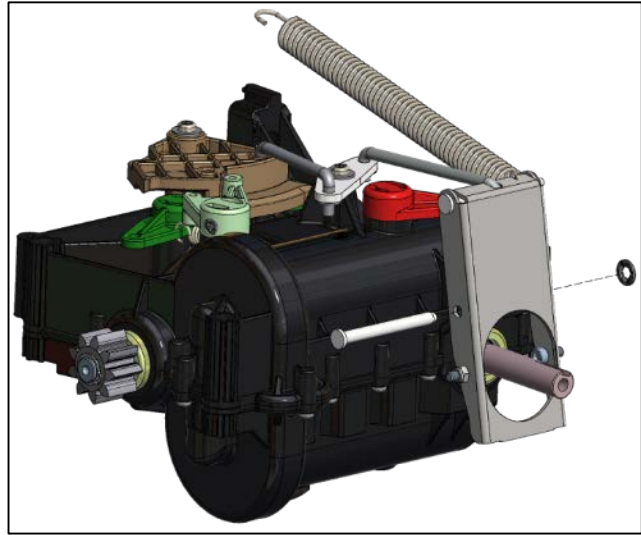
Remove the variation lever axle

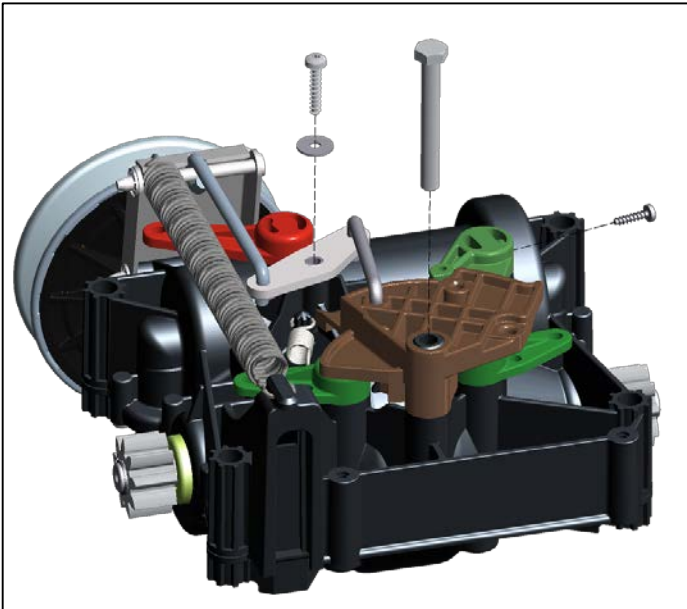
Remove screws

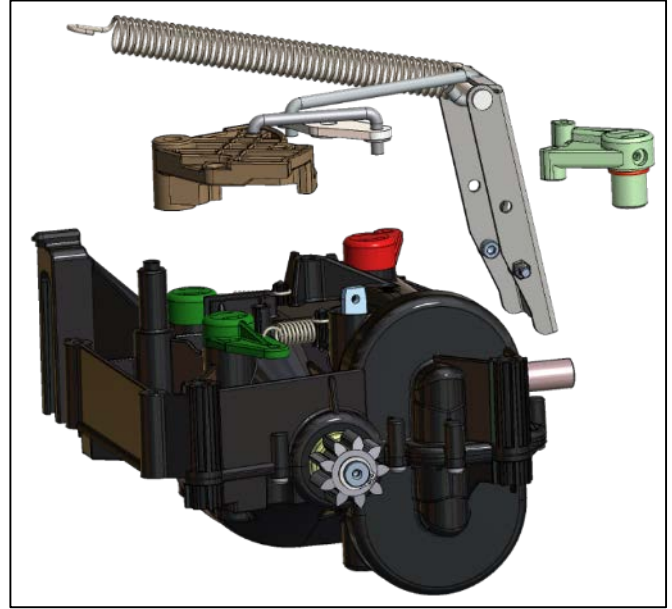
Remove controls kit

- When reinstalling, we recommend to put sealant in the inversion lever to avoid any seepage.

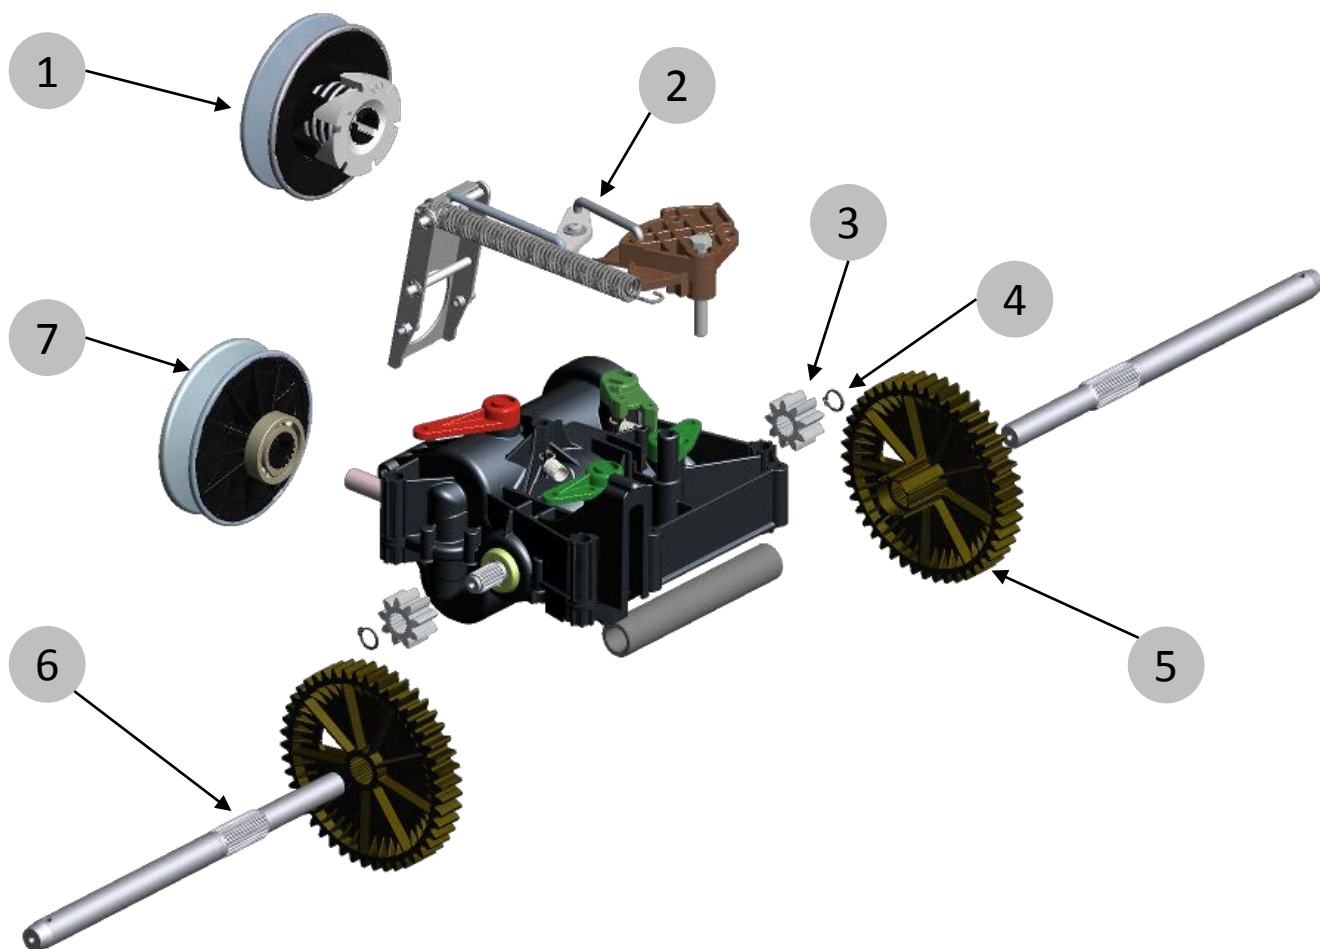
Exploded View

PART LIST		
Item	GT PN	Designation
1	GT86021	Engine Pulley
2	GT79331	Controls kit
3	GT35040	Output shaft gear
4	GT42307	Clip
5	GT35073	Axle shaft Gear
6	GT12477	Axle shaft
7	GT79135	Input Pulley

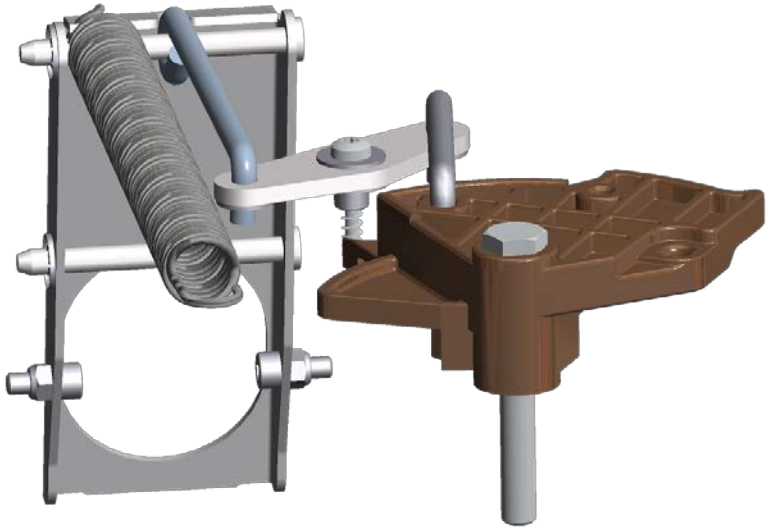
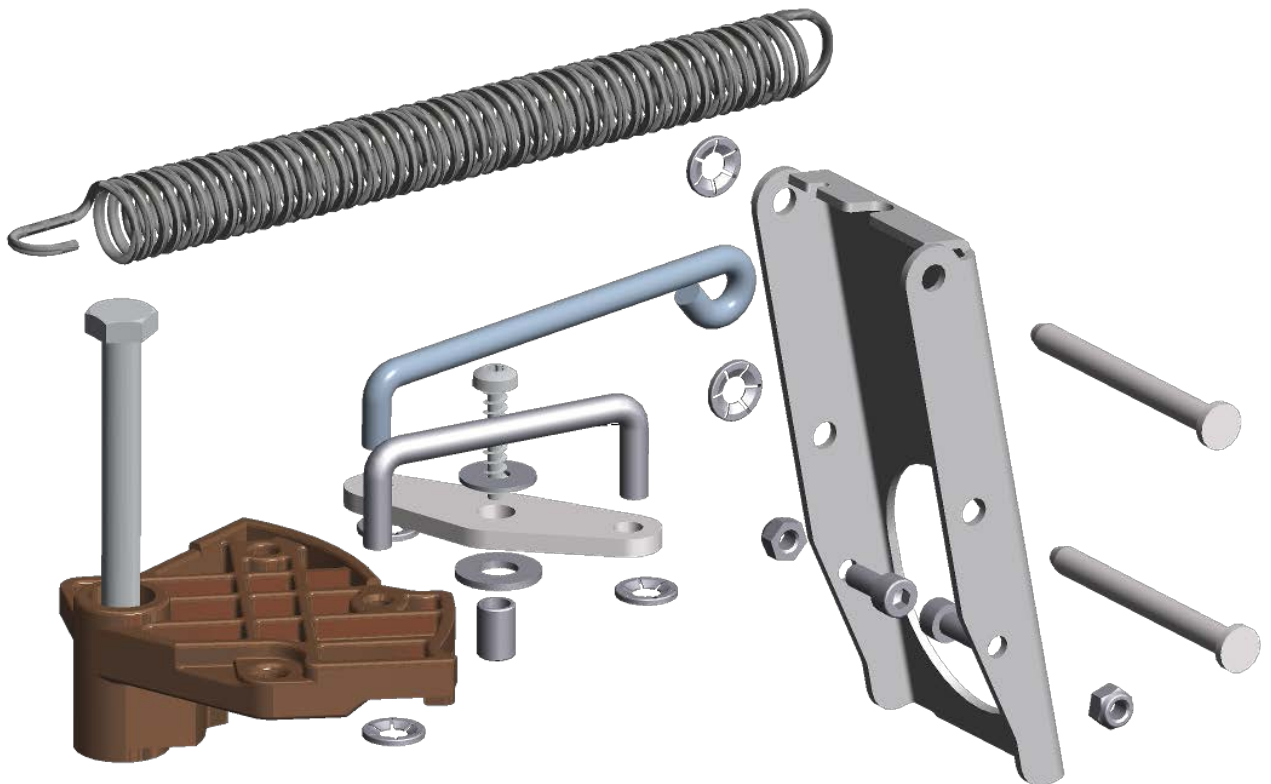
III- Controls kit

P/N GT79331
